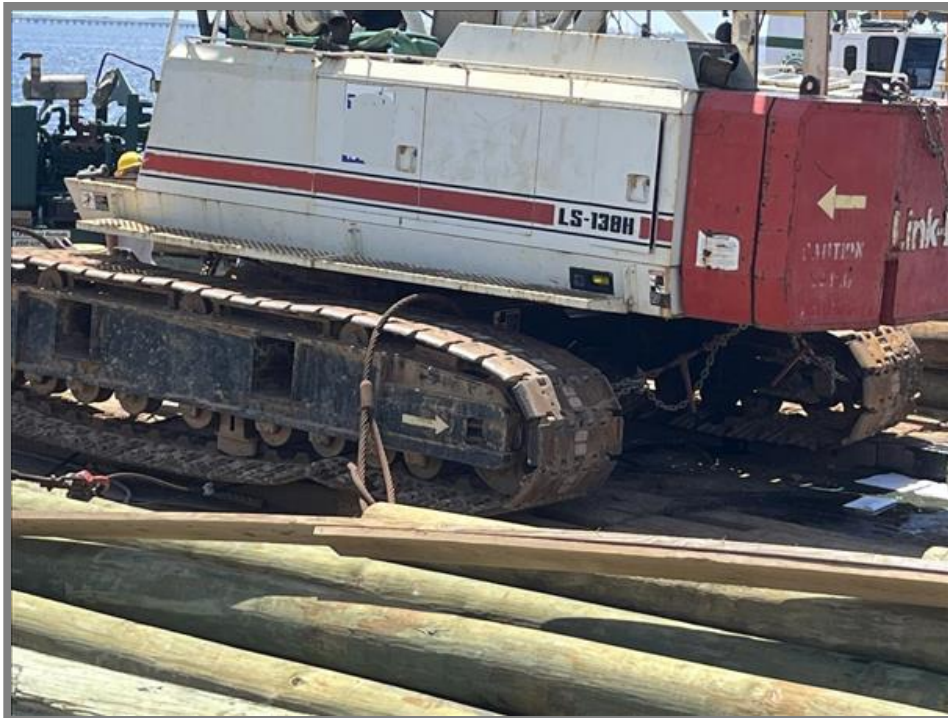
Photograph #2

Left rear corner view

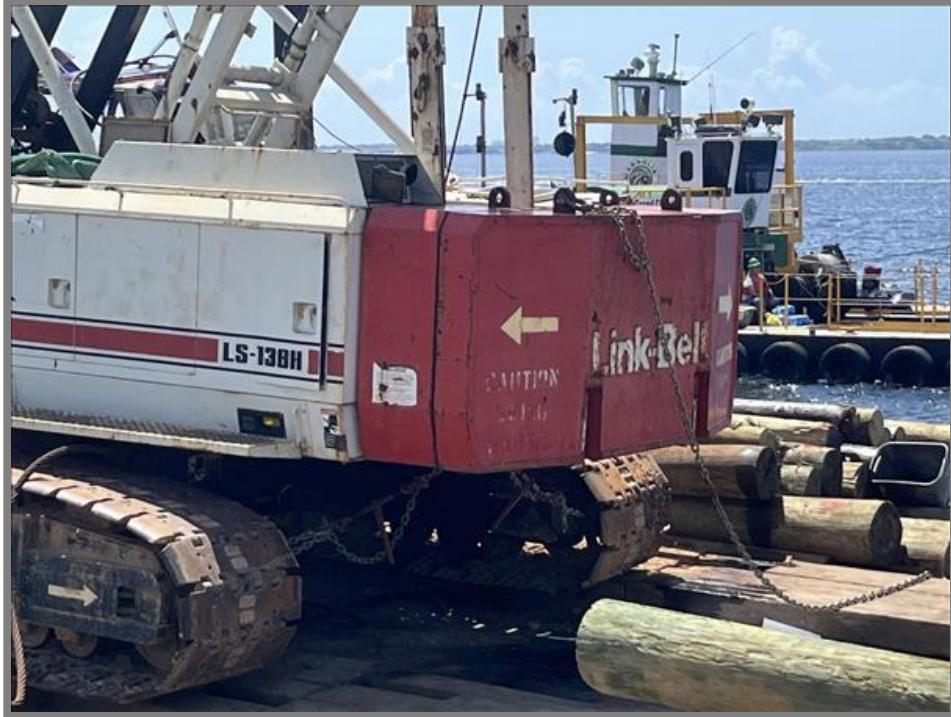
Photograph #3

View of rear panel from left side

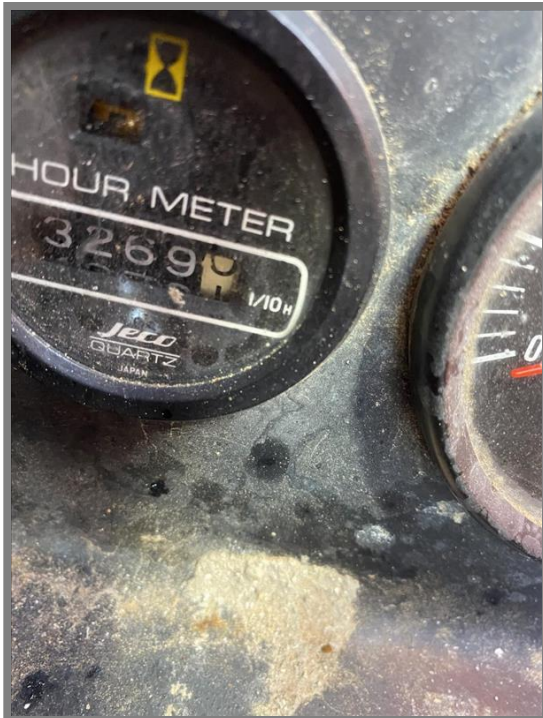
Photograph #4

View of hour meter at time of inspection

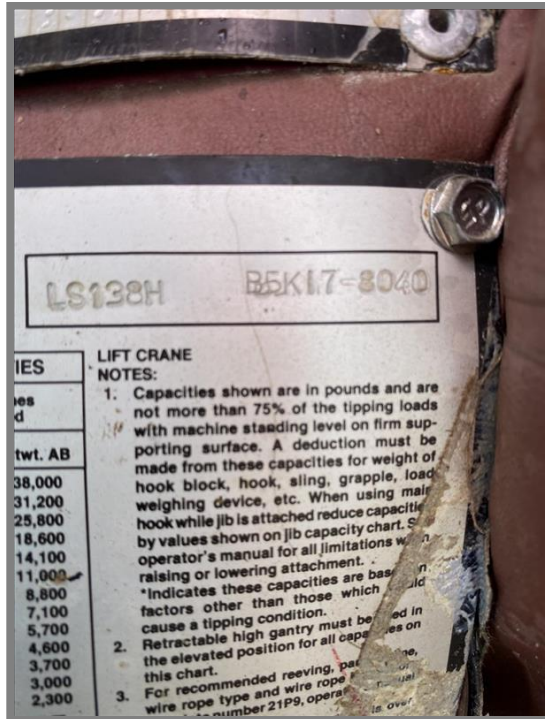
Photograph #5

Serial number plate

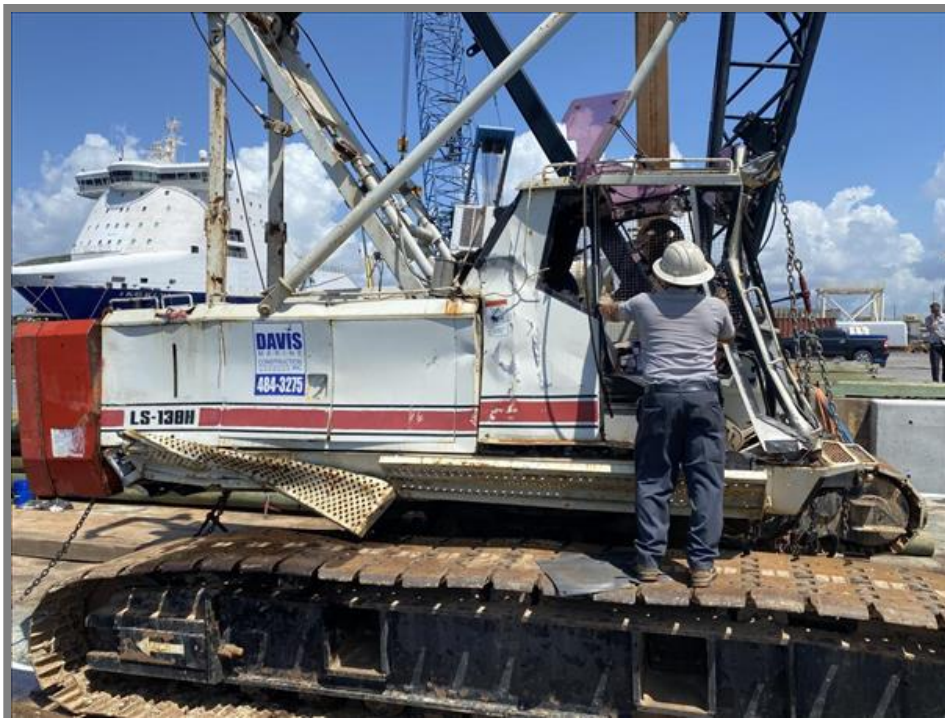
Photograph #6

Overview of right side after recovery

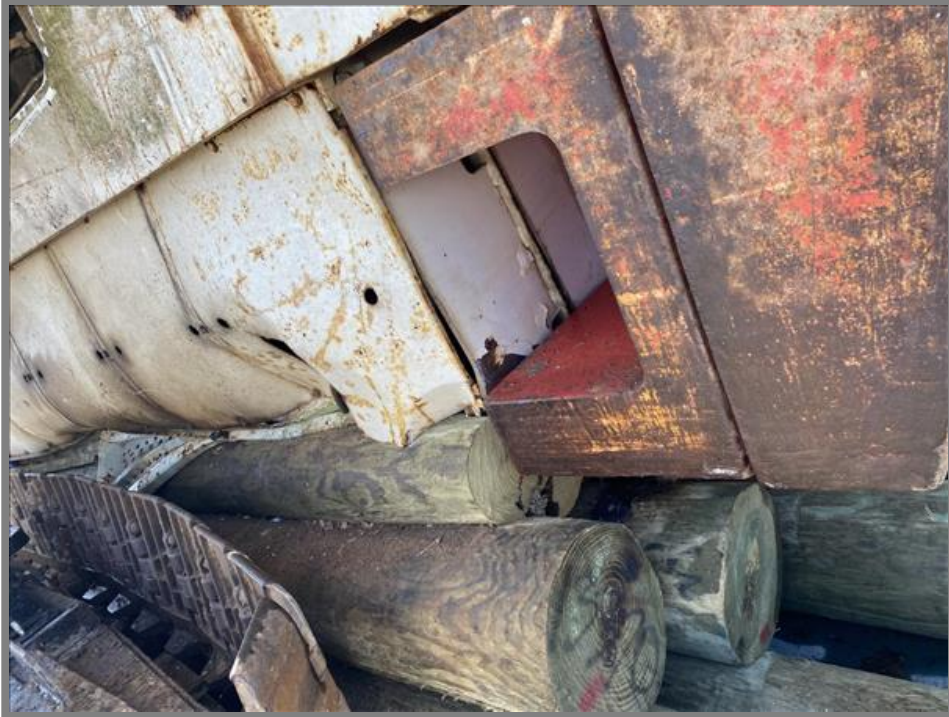
Photograph #7

Undercarriage rear section

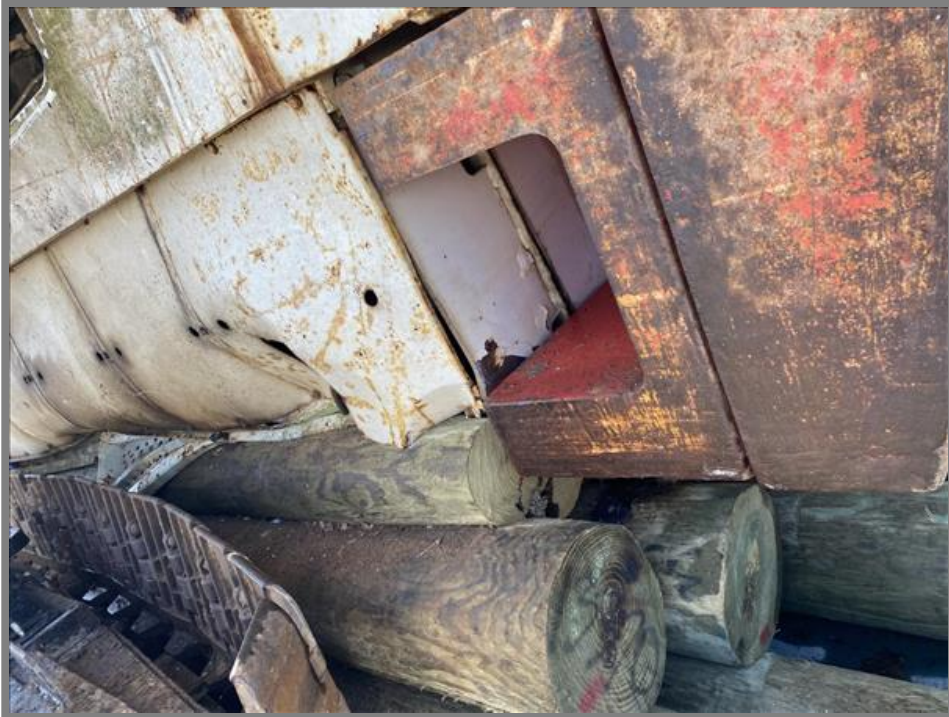
Photograph #8

View of structural damages to tunnel

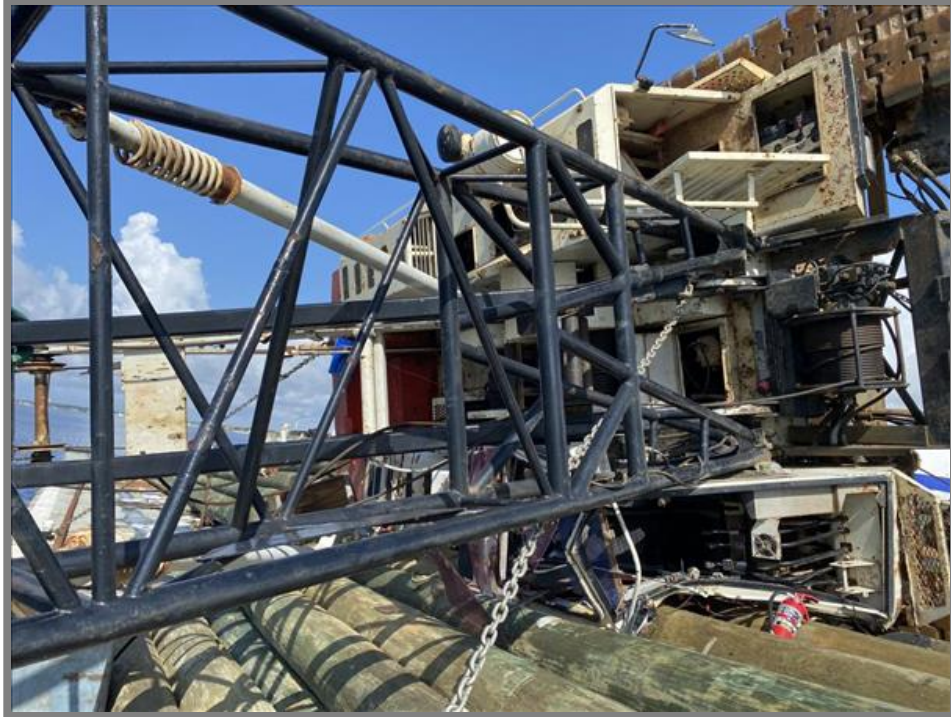
Boom base damages

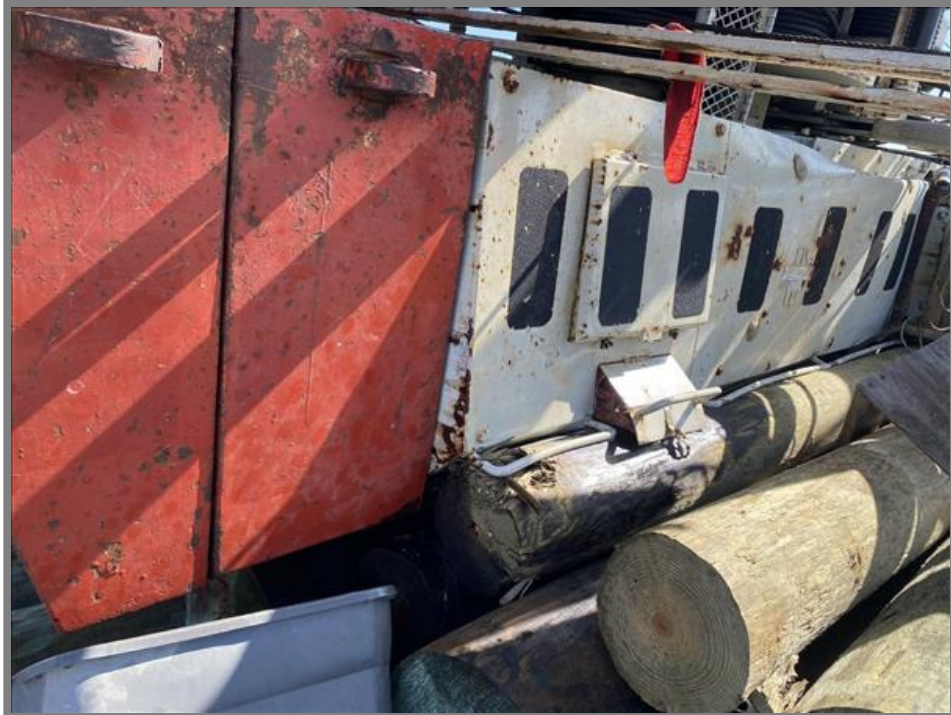
Photograph #10

View of damages to upper catwalk

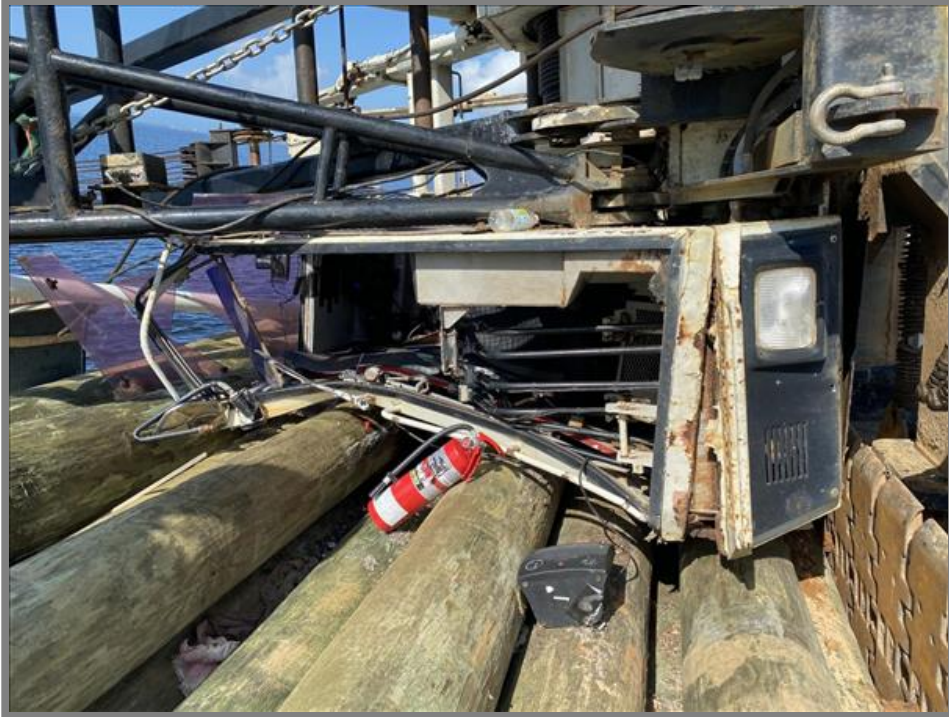
Photograph #11

Crushed cab assembly

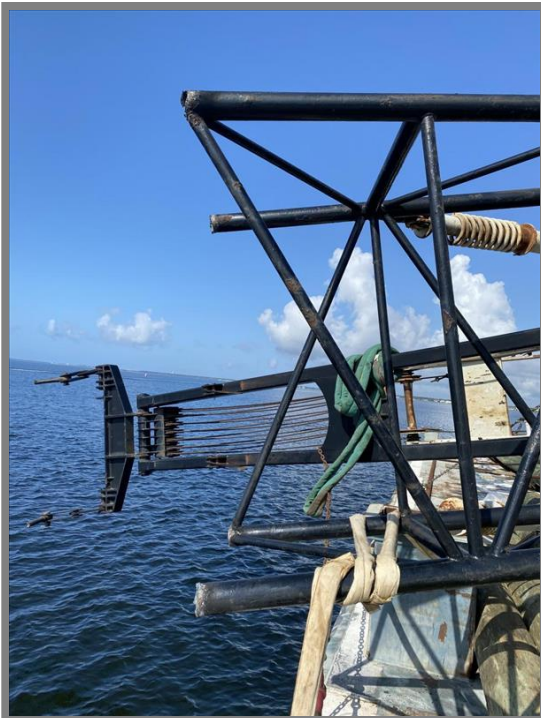
Photograph #12

Boom jib section

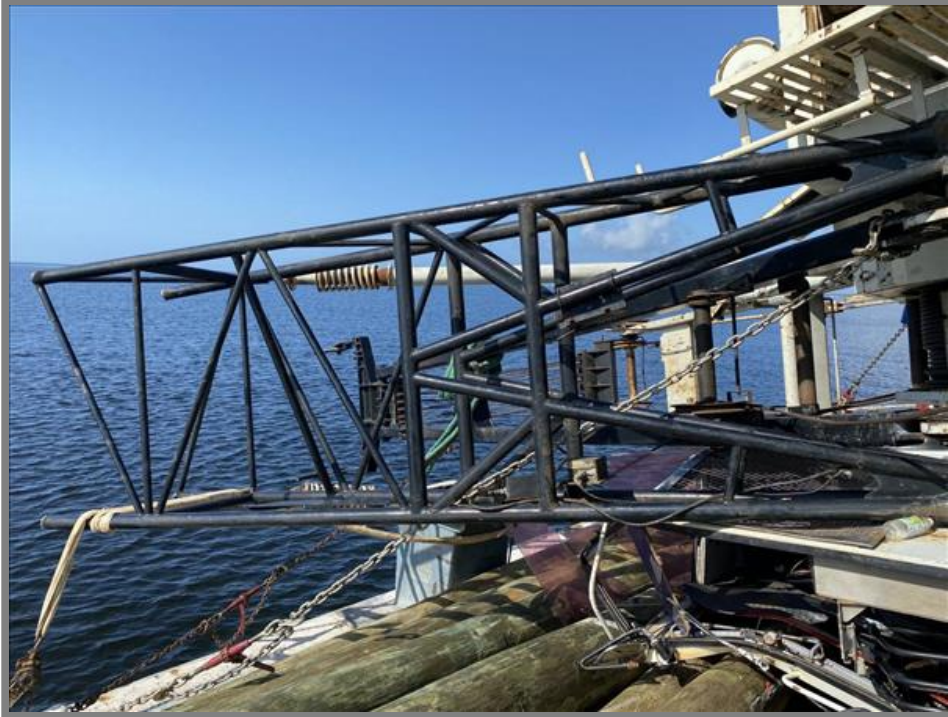
Photograph #13

Damaged base section of boom

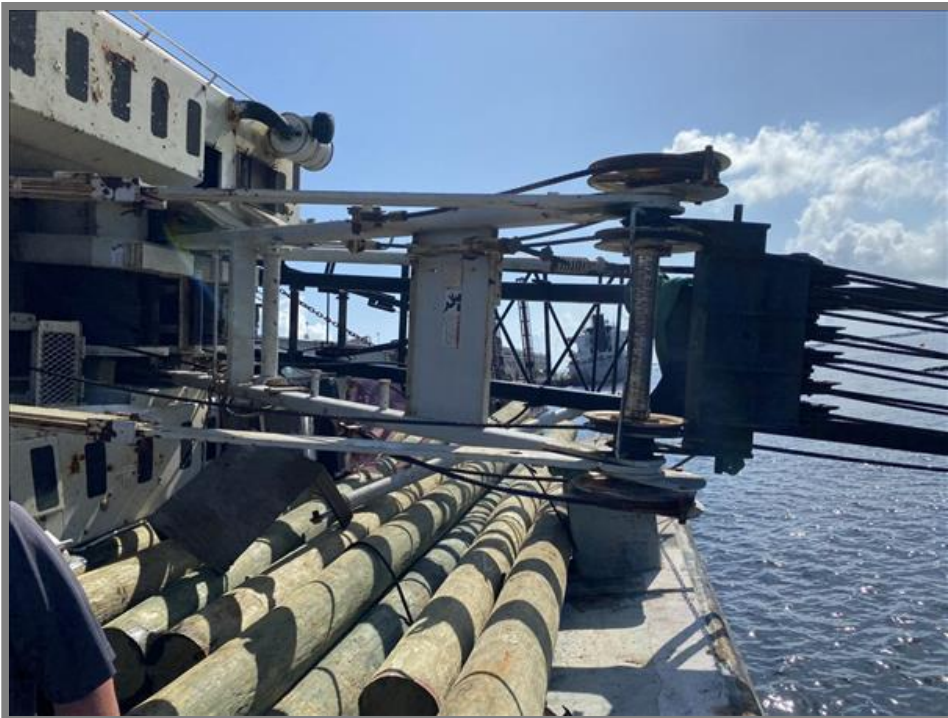
Photograph #14

View of damages to rigging

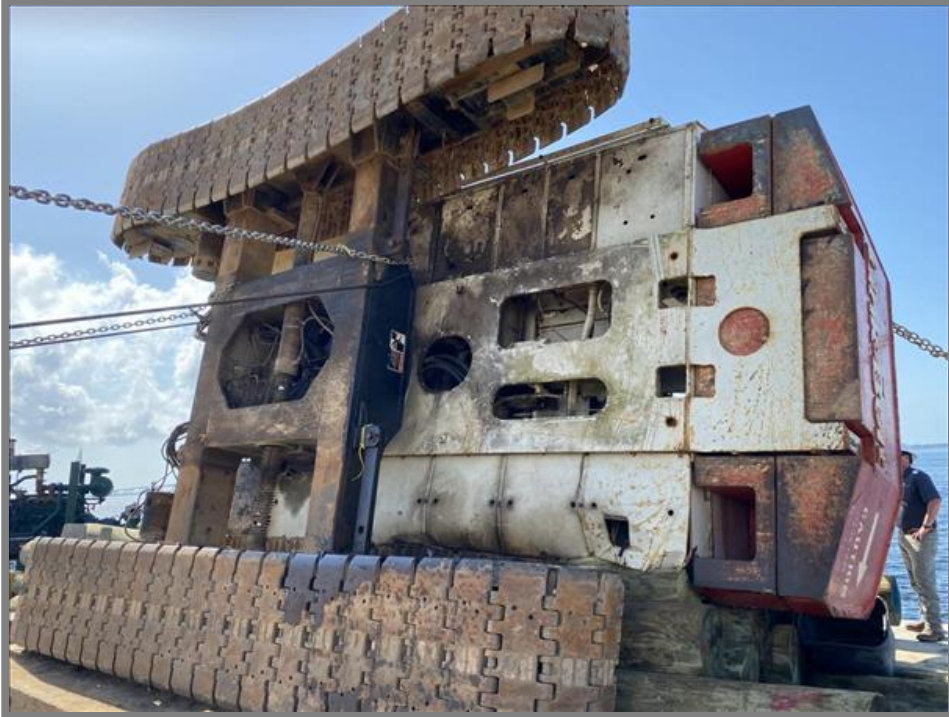
Photograph #15

View of undercarriage just prior to uprighting
